CASE STUDY

CorkSol solves damp & mould issue at 1960's East London tower block

Date Nov 2020

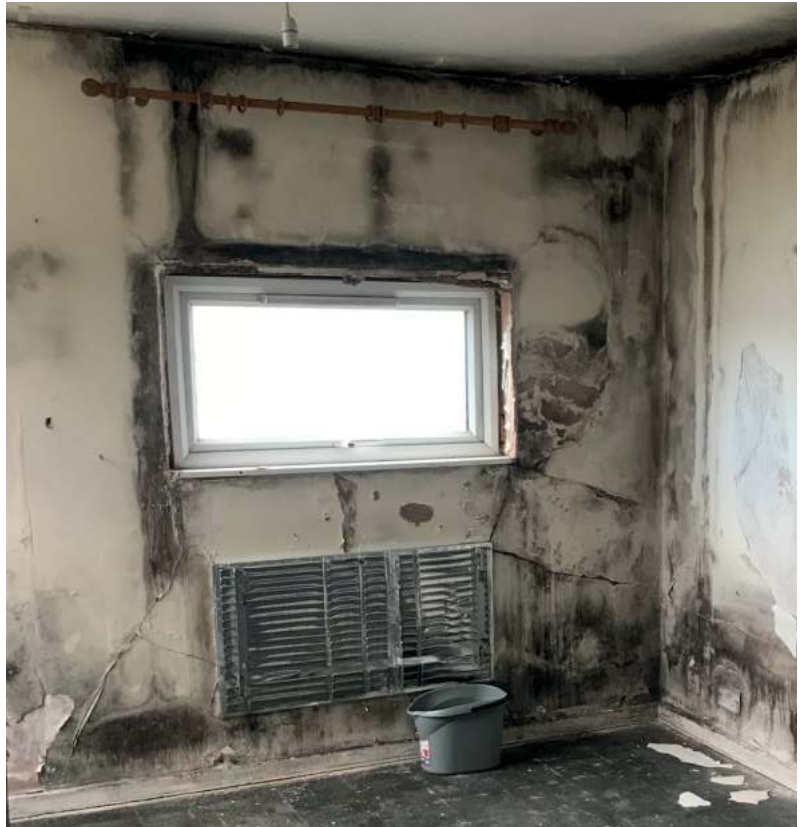
One such project was a 26-storey, 107-flat towerblock, constructed in the late 1960s of a solid concrete superstructure with a partial brick skin. At least 80% of the flats were suffering from ever-increasing **damp, mould** and **condensation problems** which had been a problem for years. The problem was mainly on the outside skin walls at ceiling and skirting board level where the airflow was low, and in the window reveals which could get very cold overnight and got worse the higher up the block you were. Steve believed there to be a number of factors which had contributed to the damp problems increasing over the years.

Black mould is rife in the flats, but especially at ceiling and floor level and around the window reveals.

Steve looked for suitable thermal wall treatments to increase the temperature of the internal walls but which wouldn't create other knock-on problems. He ruled out traditional Internal Wall Insulation (IWI) solutions as the room size would have been reduced to an unacceptable degree in such small flats (IWI solutions being typically at least 100mm deep).

Steve's final choice for the wall treatment – CorkSol **sprayed cork granules with a plaster overskim** – seemed to have the potential to resolve all these

First he cleaned down the mouldy walls with a specialist bleach wash. He then spray applied two coats of fine grain CorkSol, each coat 3mm deep, ensuring an even and continuous coverage.

Finally, the wall was given a standard 2mm skim of plaster, giving an 8mm overall depth.

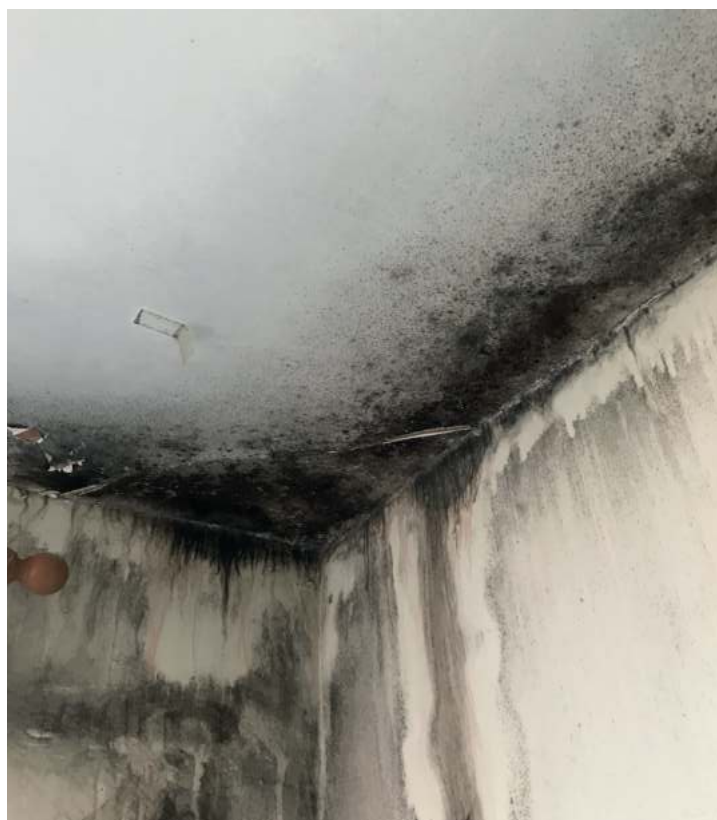
In particular, one resident of a single-bed flat on the fourth floor regularly complained several times a month to the estate management board of cold and black spot mould, that her "walls were sweating" and that her clothes and furniture were becoming

so damp that several items had to be thrown out.

An air movement survey confirmed that ventilation to the flat now should have been more than adequate but the damp was still present and the extent of the black mould continued to increase.

The most severe patch of black spot mould, just before the remedial work began.

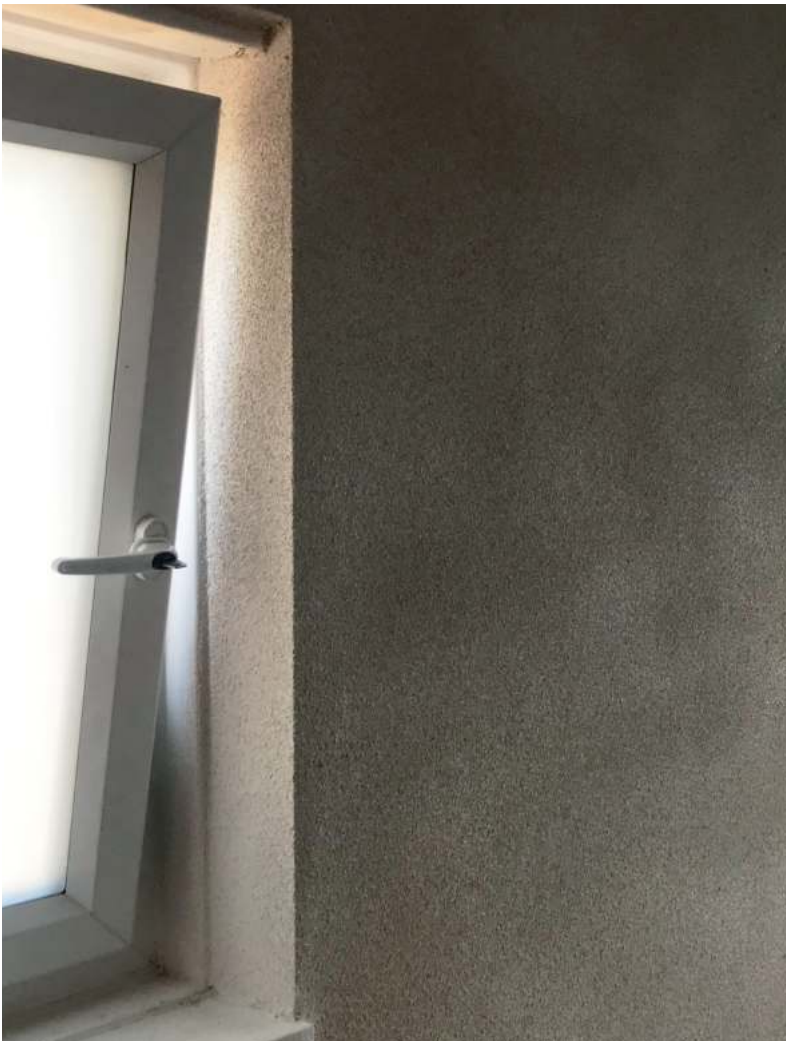
The granular CorkSol layer, spray-applied seamlessly including round the window reveal, ready to accept the final plaster skim.

The solution gives a **powerful thermal insulating performance** for its slim size, and eliminates any fears of cold bridging or air gaps as it is sprayed on in a single seamless layer, including around window reveals and returns. Another key benefit of CorkSol is that the material is **highly breathable** (vapour-open) meaning that any residual dampness in the walls can transpire away harmlessly over time.

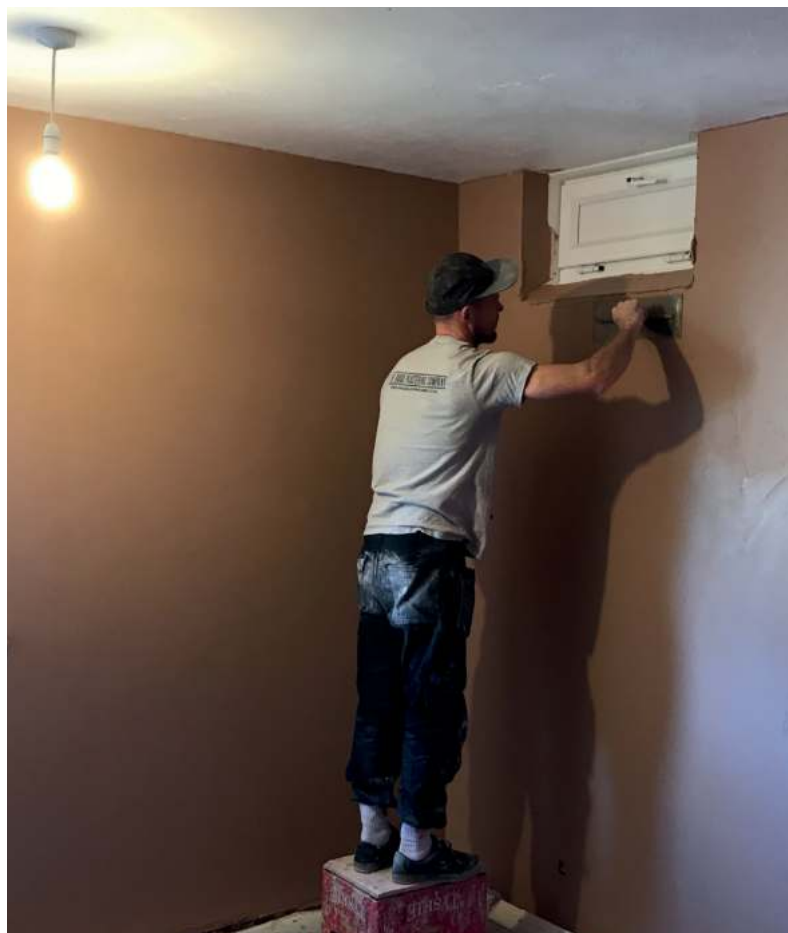
The Good Plastering Company apply the final plaster skim, leaving the room only 8mm smaller.
