CASE STUDY

CorkSol is proven as leading Thin Internal Wall Insulation solution

New SprayCork reduces heat loss through walls by more than 30%

Date Nov 2020

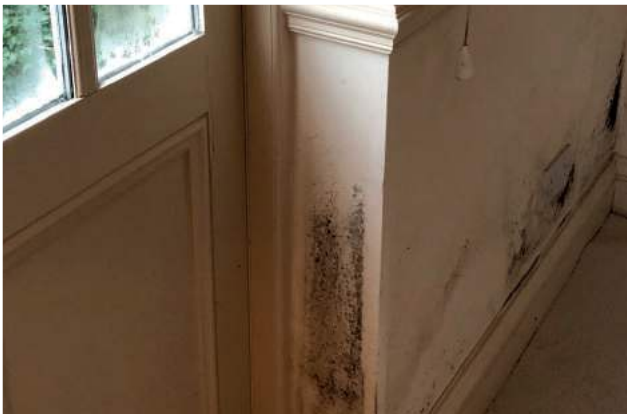
Mould and condensation problems around window reveals and corners

The small gas boiler struggled to keep the property warm in winter and there was mould and damp evident on the walls, primarily in the corners and around the reveals of the French doors and windows. By drilling into the walls we confirmed that there was no existing insulation, just plasterboard dot and dab fixed direct to the 300mm thick stone. The large dabs holding the plasterboard in place were cold to the touch, and the IR camera confirmed clearly that they were acting as a strong cold bridge.

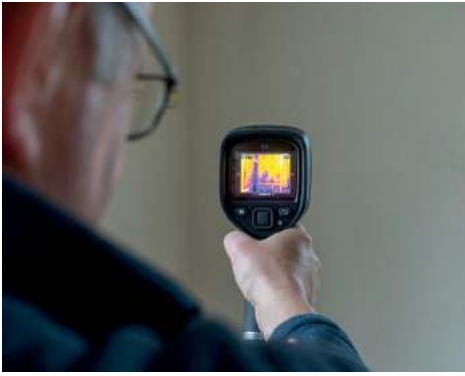
Infra Red imaging before treatment

now fully dry, it made for a great test wall. We determined the exact mounting point for the test rig using IR camera images to avoid those cold bridge dabs which might skew the test.

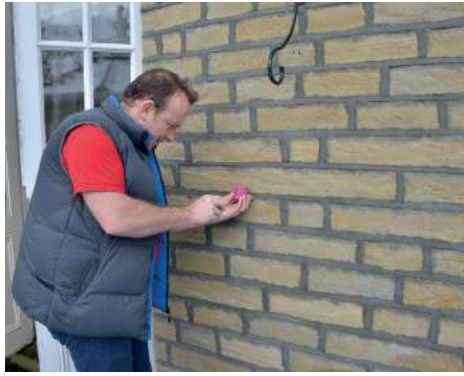
Exterior set-up of U-value testing sensor

The U-value test kit used, an ISO 9869-1:2014 approved Swiss system, requires three measurements - internal

temperature, external temperature and heat flux - to be recorded every minute for at least 72 hours. The test requires internal and external temperatures to be significantly different, so the fact that we were running the test in winter and had control over the central heating system helped.

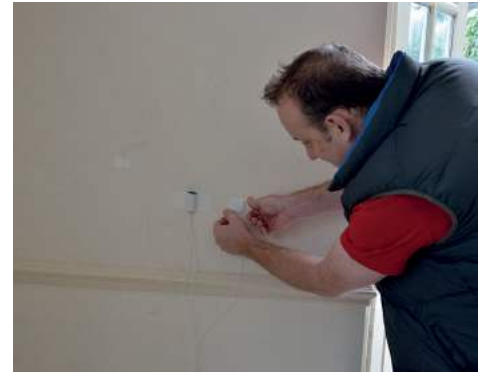
Pre-treatment set-up of U-value testing sensor

The wall was tested before application of SprayCork, and a U-value of 1.58W/m²K was obtained. This is a reasonably good performance for an uninsulated stone wall, but well within the expected range.

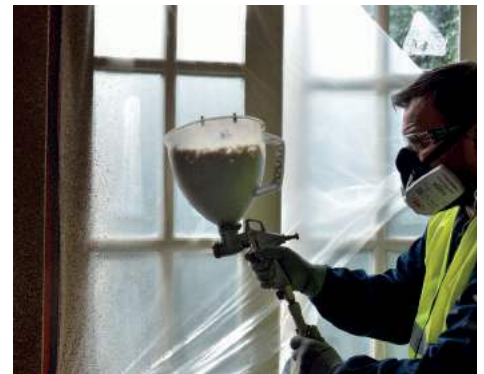
Continuous, seamless application

SprayCork was spray applied seamlessly direct to the existing plasterboard, across the whole internal surface of the exterior walls and around the window reveals. Application was in two layers giving an overall depth of 5-6mm. After drying, the walls were skimmed with 2mm of standard gypsum plaster, all in the same day.

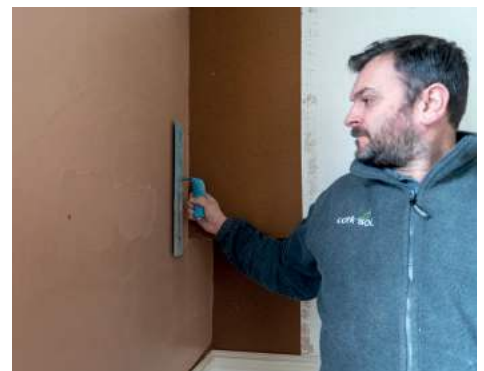
Plaster skim directly over the SprayCork

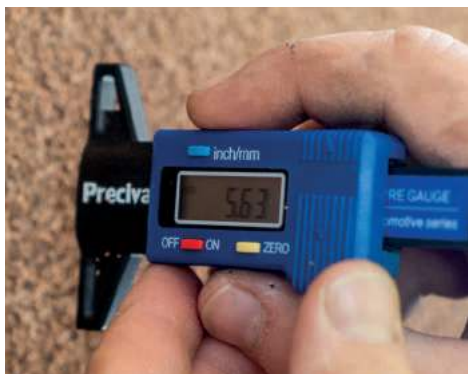
Thin layer solution

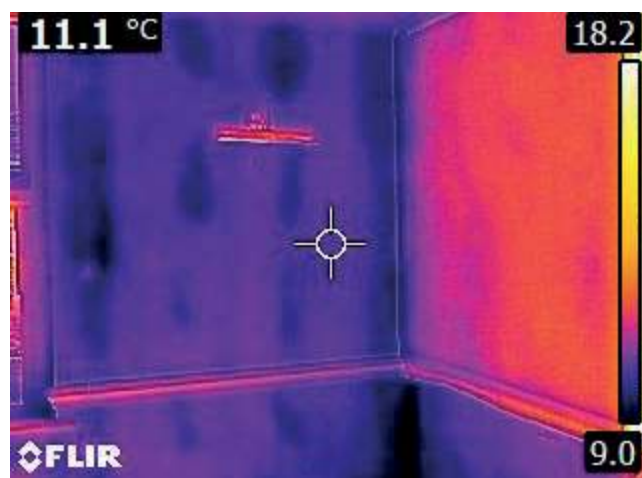
IR image captured part way through application. The left-hand wall has not yet been treated and is cool with dramatic cold bridges (purple blotches). The SprayCork treated right-hand wall is much warmer and the cold are eliminated (solid orange / red)

Immediately there were signs that there were significant improvements in thermal performance. IR images showed a visible reduction in the cold bridges which had been caused by the plaster dabs and around the internal corners. This was visual confirmation of SprayCork's effectiveness at increasing the surface temperature of the treated walls and so controlling condensation and mould.

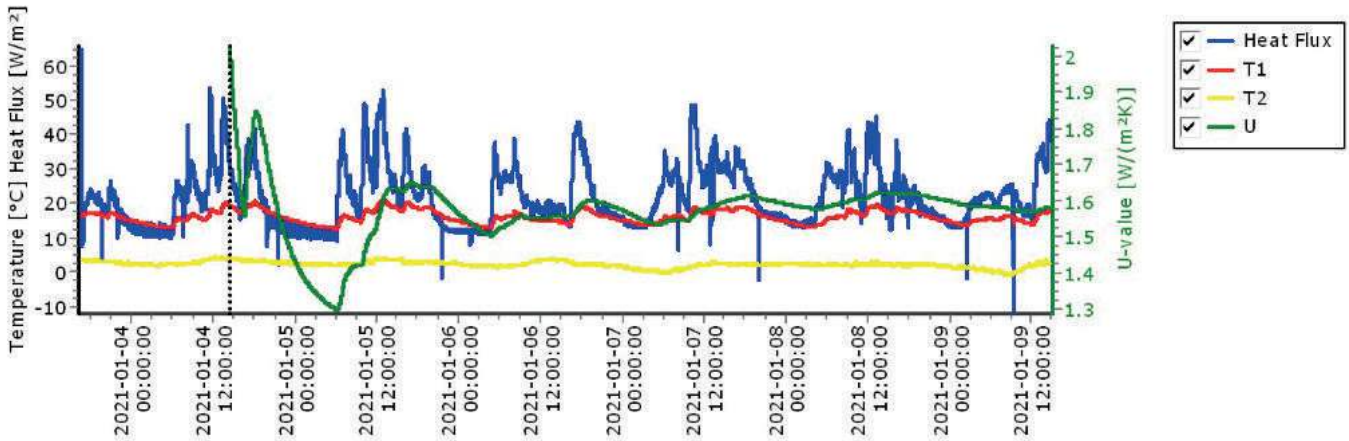
U-value analysis using average method (Section 7.1, ISO 9869-1:2014):

Analysis start time	2021-01-04 14:35:30	U-value w/o last 24h (U24)	1.62 W/(m ² K)
Analysis end time	2021-01-09 14:35:30	U-value first 2/3 (U2/3)	1.59 W/(m ² K)
Analysis period	120h	U-value last 2/3 (U2/3)	1.60 W/(m ² K)
U-value:	1.58W/(m²K)	dU24:	-2.4%
		dU2/3:	-0.3%
		dR24:	3.3%
		dR2/3:	0.4%

Measurement data fulfils requirements of ISO 9869-1:2014 section 7.1

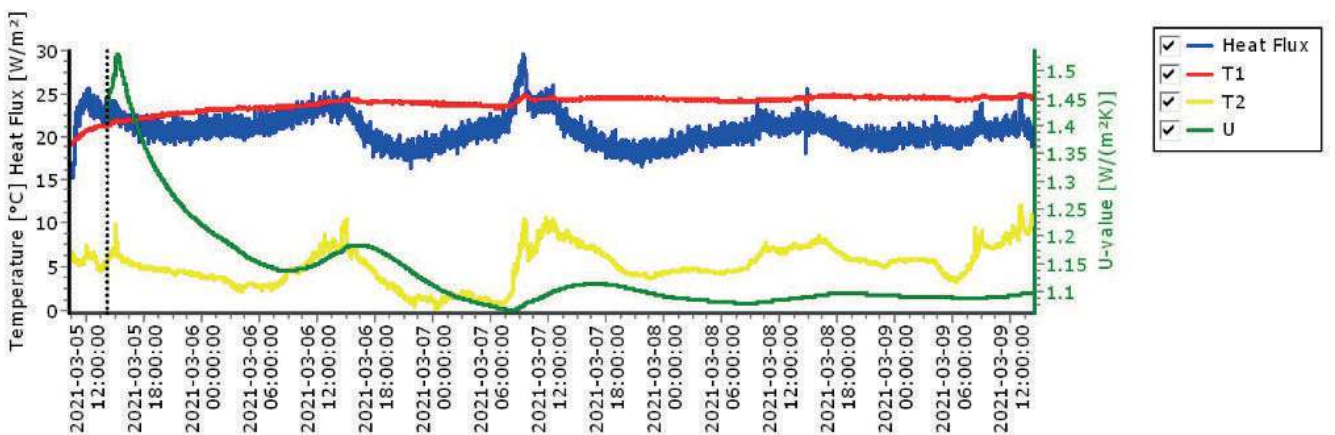
U-value analysis using average method (Section 7.1, ISO 9869-1:2014):

Analysis start time	2021-03-05 14:10:34	U-value w/o last 24h (U24)	1.09 W/(m ² K)
Analysis end time	2021-03-09 14:10:34	U-value first 2/3 (U2/3)	1.11 W/(m ² K)
Analysis period	96h	U-value last 2/3 (U2/3)	1.09 W/(m ² K)
U-value:	1.10W/(m²K)	dU24:	0.8%
		dU2/3:	2.1%
		dR24:	-1.0%
		dR2/3:	-2.5%

Measurement data fulfils requirements of ISO 9869-1:2014 section 7.1

U-value testing output data showing the 30.4% reduction in heat loss from 1.58 to 1.10 W/(m²K)

After application, the U-value testing kit was re-mounted in the same spot as for the first test, under the same conditions. Four days later, the test was complete to ISO9869 standard, and the resulting U-value had improved to 1.10W/m²K.

By improving U-value from 1.58 to 1.10, the SprayCork had caused a 30.4% reduction in heat loss through the wall.
